PAWEŁ KONCZEWSKI, JERZY PIEKALSKI

THE STREETS OF MEDIEVAL WROCLAW – METHODS OF CONSTRUCTION AND FUNCTIONS

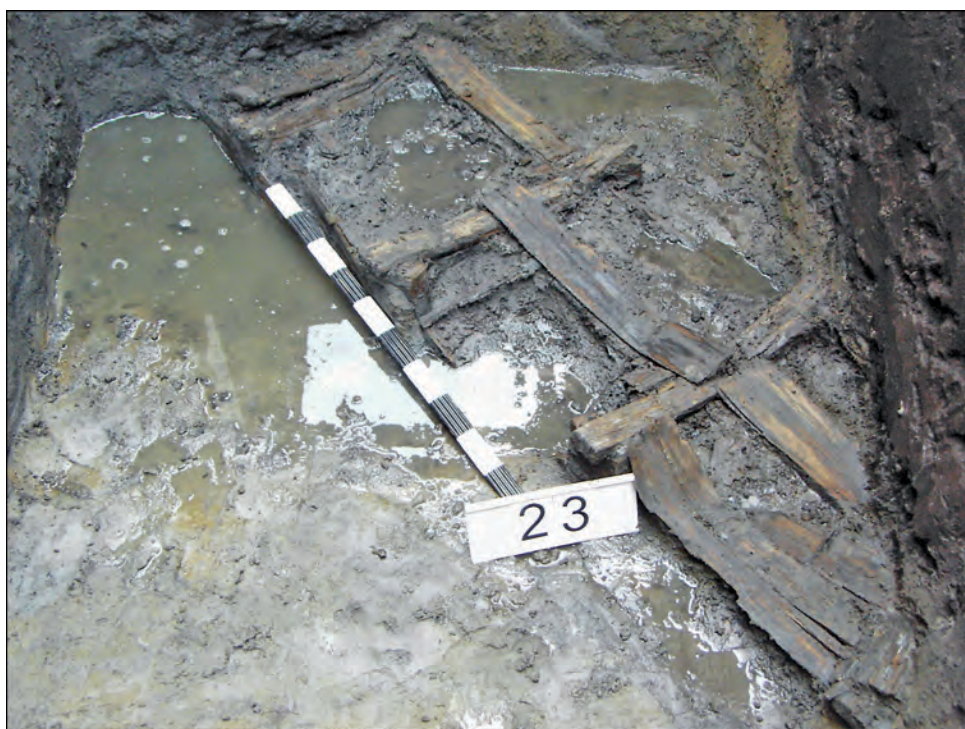
Fig. 3. Wrocław, Szewska Street/Nankera Square. Timber-lined surface of a pedestrian walkway. Photo. P. Konczewski

with bundles of brushwood or with timber recycled from repaired ramparts (fig. 2ab, Bykowski et al. 2004, p. 120, 148). The left bank of the Odra mostly had dirt roads although some of the more waterlogged stretches may have had raised wooden walkways for pedestrian traffic. It was so in Szewska Street, on the corner with Nankera Square (fig. 3).

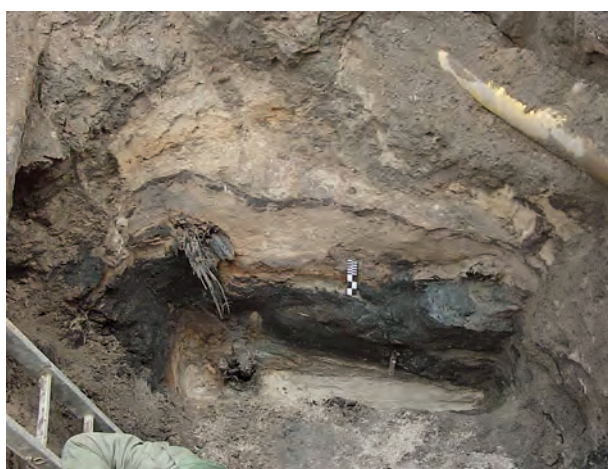
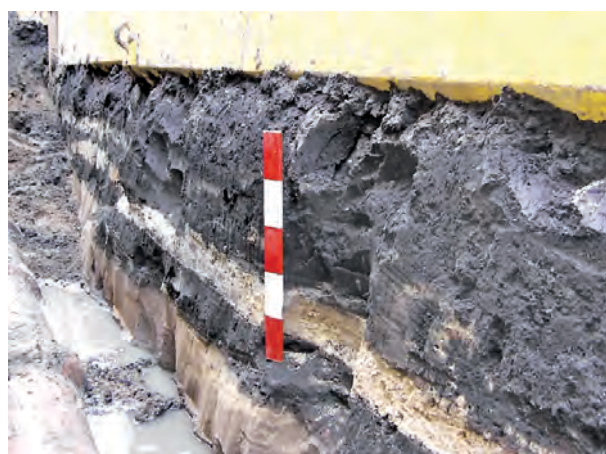
Fig. 6. Wrocław, Kielbaśnicza Street. Layers of humus and sand. Photo. R. Kamiński

(fig. 6). More rarely, the edge of the street was surfaced with a pavement of pebbles, laid right over the muck or humus, something which has been observed in a number of locations in Szewska Street.

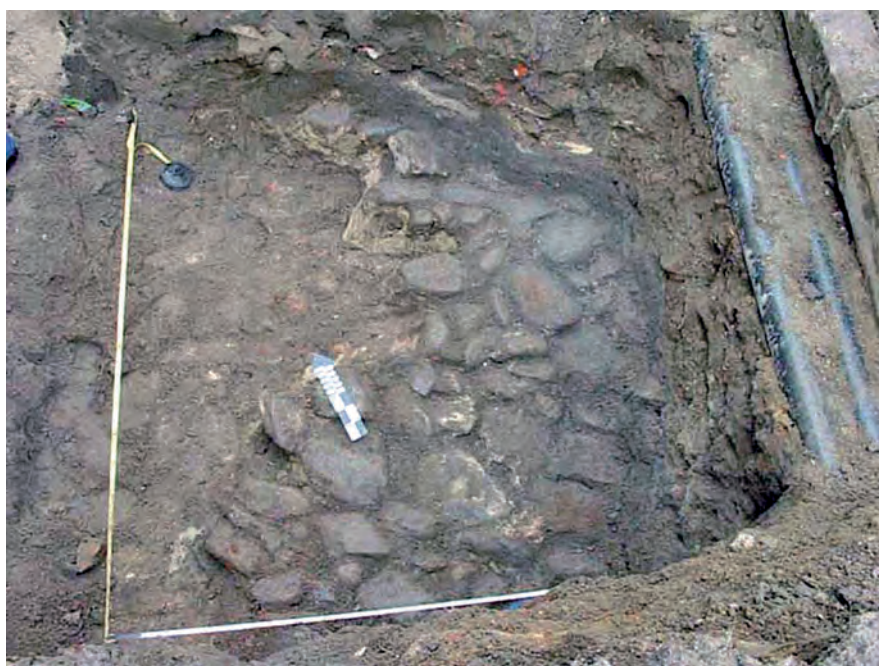
Fig. 7. Wrocław, Kielbaśnicza Street. Stone pavement, 14th century. Photo. R. Kamiński

In point of fact, the most advanced method of keeping the layer of sand in the street more or less intact was to cover it with a pavement of stones. In Wrocław pavements were built of post-glacial cobbles which are typical in the European Lowland (fig. 7). The best quality pavements were laid over a bed of pure sand which helped to level and drain the ground below and create a stable substrate for the stonework. This resulted in a rise of the ground level by 20–40 cm, sometimes, even by up to 80 cm. The diameter of the cobbles was on average 15 cm, at most, around 20 cm. They were laid close together in stretches bounded by courses of larger stones or rough planks set vertically (on end). The earliest stone pavements of Wrocław, in its Market Square, have been dated to late 13th century (Buśko 1997, p. 118; Płonka, Wiśniewski 2002, p. 121n; Bresch et al. 2002, p. 14n). Their distribution there was localised. They lined the passages across the market and some of the access ways to some market stalls.

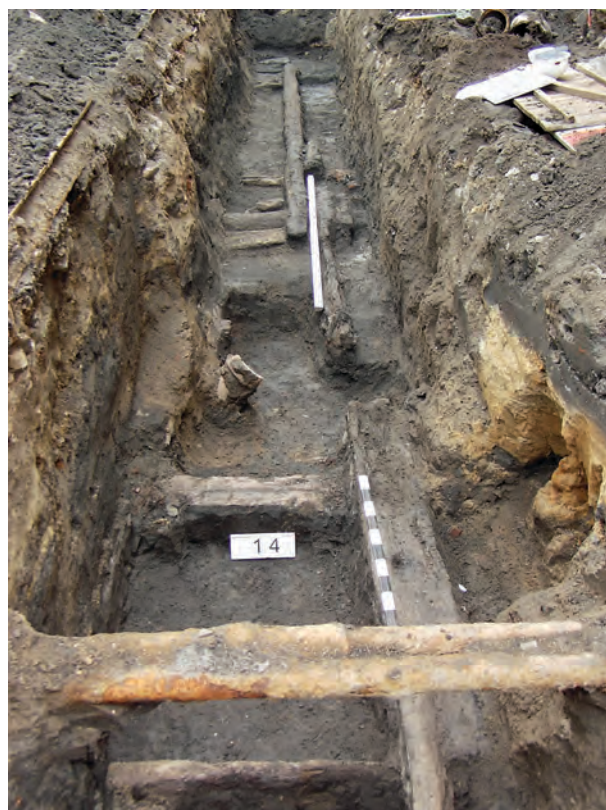
Fig. 8. Wrocław, Szewska Street. Partly dismantled road surface. Photo. P. Konczewski

a thick layer or muck. When these timber structures had served their purpose they were partly dismantled in order to recover the better fragments of oak-beams and rough planks (fig. 8). This practice throws light on the ways the timber resource was managed. Road surfaces were built of raw material recycled after several score years in service in other structures, mostly buildings, bought at a lower price. And even the soggy wood battered from long years in use in the street was still considered worth recovering.
