WRATISLAVIA ANTIQUA

STUDIA Z DZIEJÓW WROCŁAWIA
STUDIES ON THE HISTORY OF WROCŁAW

VI. SANITATION AND STREET SURFACE CONSTRUCTION

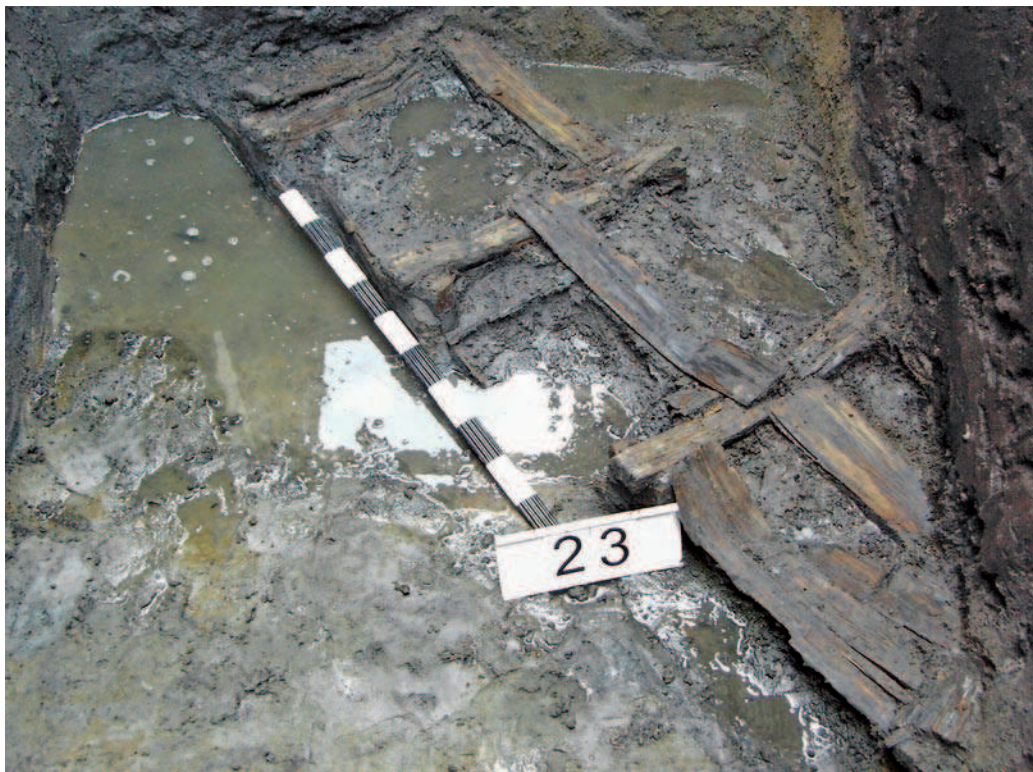
Fig. 94. Wrocław, Szewska Street/bishop Nanker Square. Timber-lined surface of a pedestrian walkway. Konczewski and Piekalski 211

similar to the suburbium below Prague Castle (Fig. 17). The material used in road construction was oak from dismantled and rebuilt ramparts (Bykowski et al. 2004). In addition to durable structures of heavy oak logs, there is evidence also of lighter and more perishable surfaces lined with brushwood. In the proto-urban settlement on the left bank, timber was used in surfacing the streets, but also footpaths, less than a metre wide (Fig. 94).

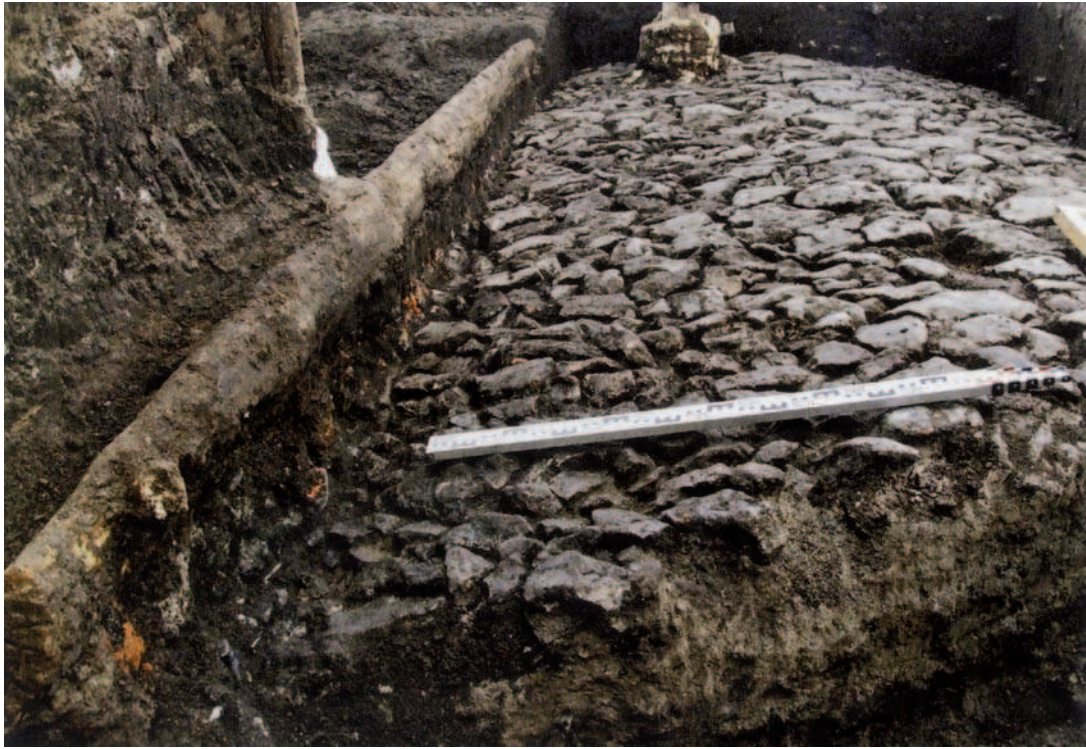
Fig. 100. Krakow, Main Market Square, cobbled surface to the north of the Cloth Hall. Dryja et al. 2010. Photo. Wojciech Głowa

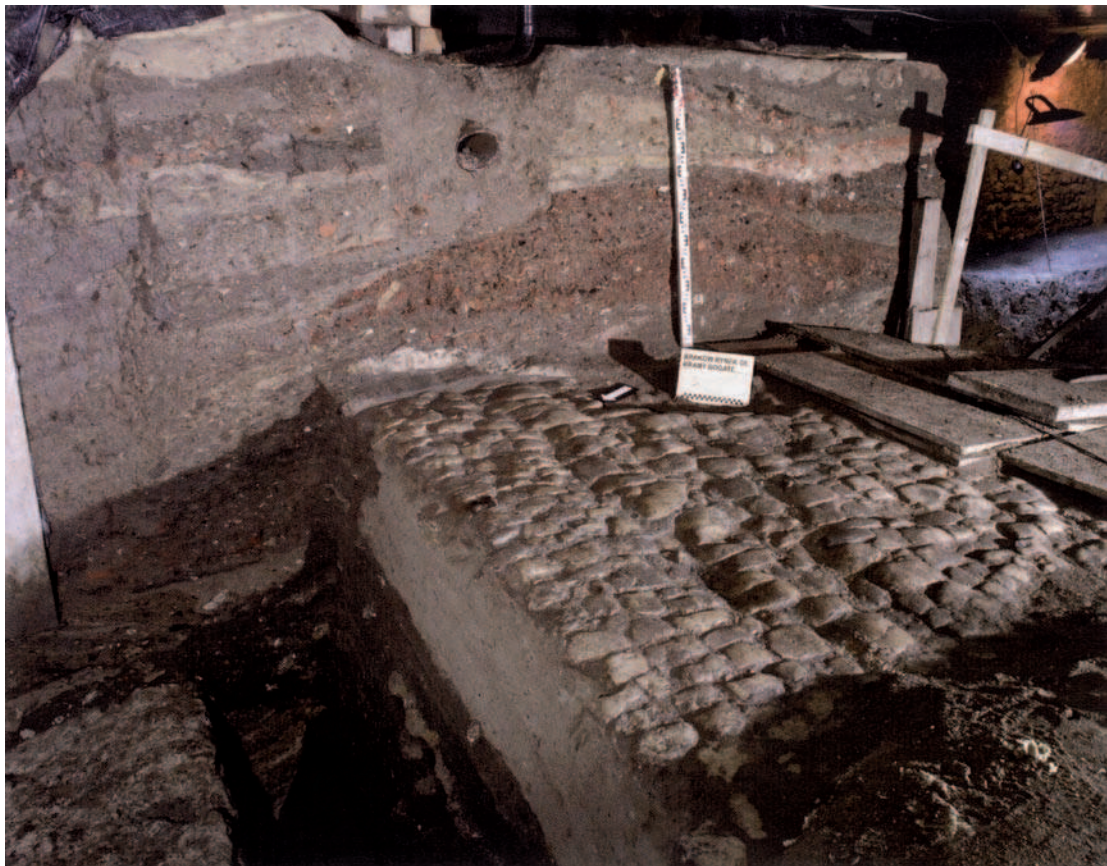
Fig. 101. Krakow, Main Market Square, cobbled surface between stalls. Dryja et al. 2010. Photo. T. Kalarus

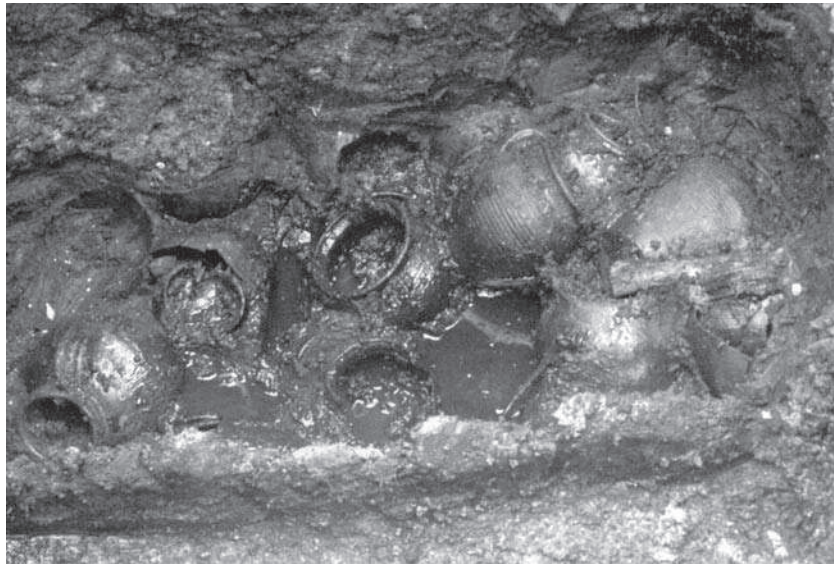
Fig. 103. Most, cesspit. Klápště et al. 2002.

some researchers from related disciplines have begun to describe our branch of study jokingly as *Kloakenarchäologie* (Fig. 103). In inventories recovered during the investigation of these structures we find: ceramic, glass and wooden vessels, well-preserved leather and textile objects, small finds made of bone and antler, an occasional wax tablet, merchant's seals, toys and a number of other finds, sometimes quite unexpected, such as eyeglasses. Cesspits helped improve the level of sanitation in the medieval town because they could be used over a long period, new pits could be installed next to those already full or they could be emptied periodically and had the form of a lined cesspit. They allowed liquid waste to drain away and the more offensive solids to decay to some extent. The cleaning out of cesspits is confirmed for the western area of Central Europe by written sources, the earliest from the 14th century (Gechter 1987, 246–248). In Wrocław, the first references date from after 1350 (Goliński 2011a). Findings from archaeological fieldwork suggest that at least a part of their contents may have been removed. Some medieval cesspits had a much later fill next to them. Analysis suggests that some of these structures continued in use for several decades. With so many different methods of disposing of cesspit contents, neither written or archaeological sources can supply the whole truth about the disposal of faeces in the town. The contents of a cesspit, collected by nightmen, could be buried at some other location in the town – as documented by finds of so-called unlined cesspits observed by archaeologists (Piekalski, Płonka and Wiśniewski 1991; Buśko 1996; Niemiec 2007); or they could be removed from the town for
