#### MARTIN VYŠOHLÍD

# NÁMĚSTÍ REPUBLIKY (REPUBLIC SQUARE) IN PRAGUE

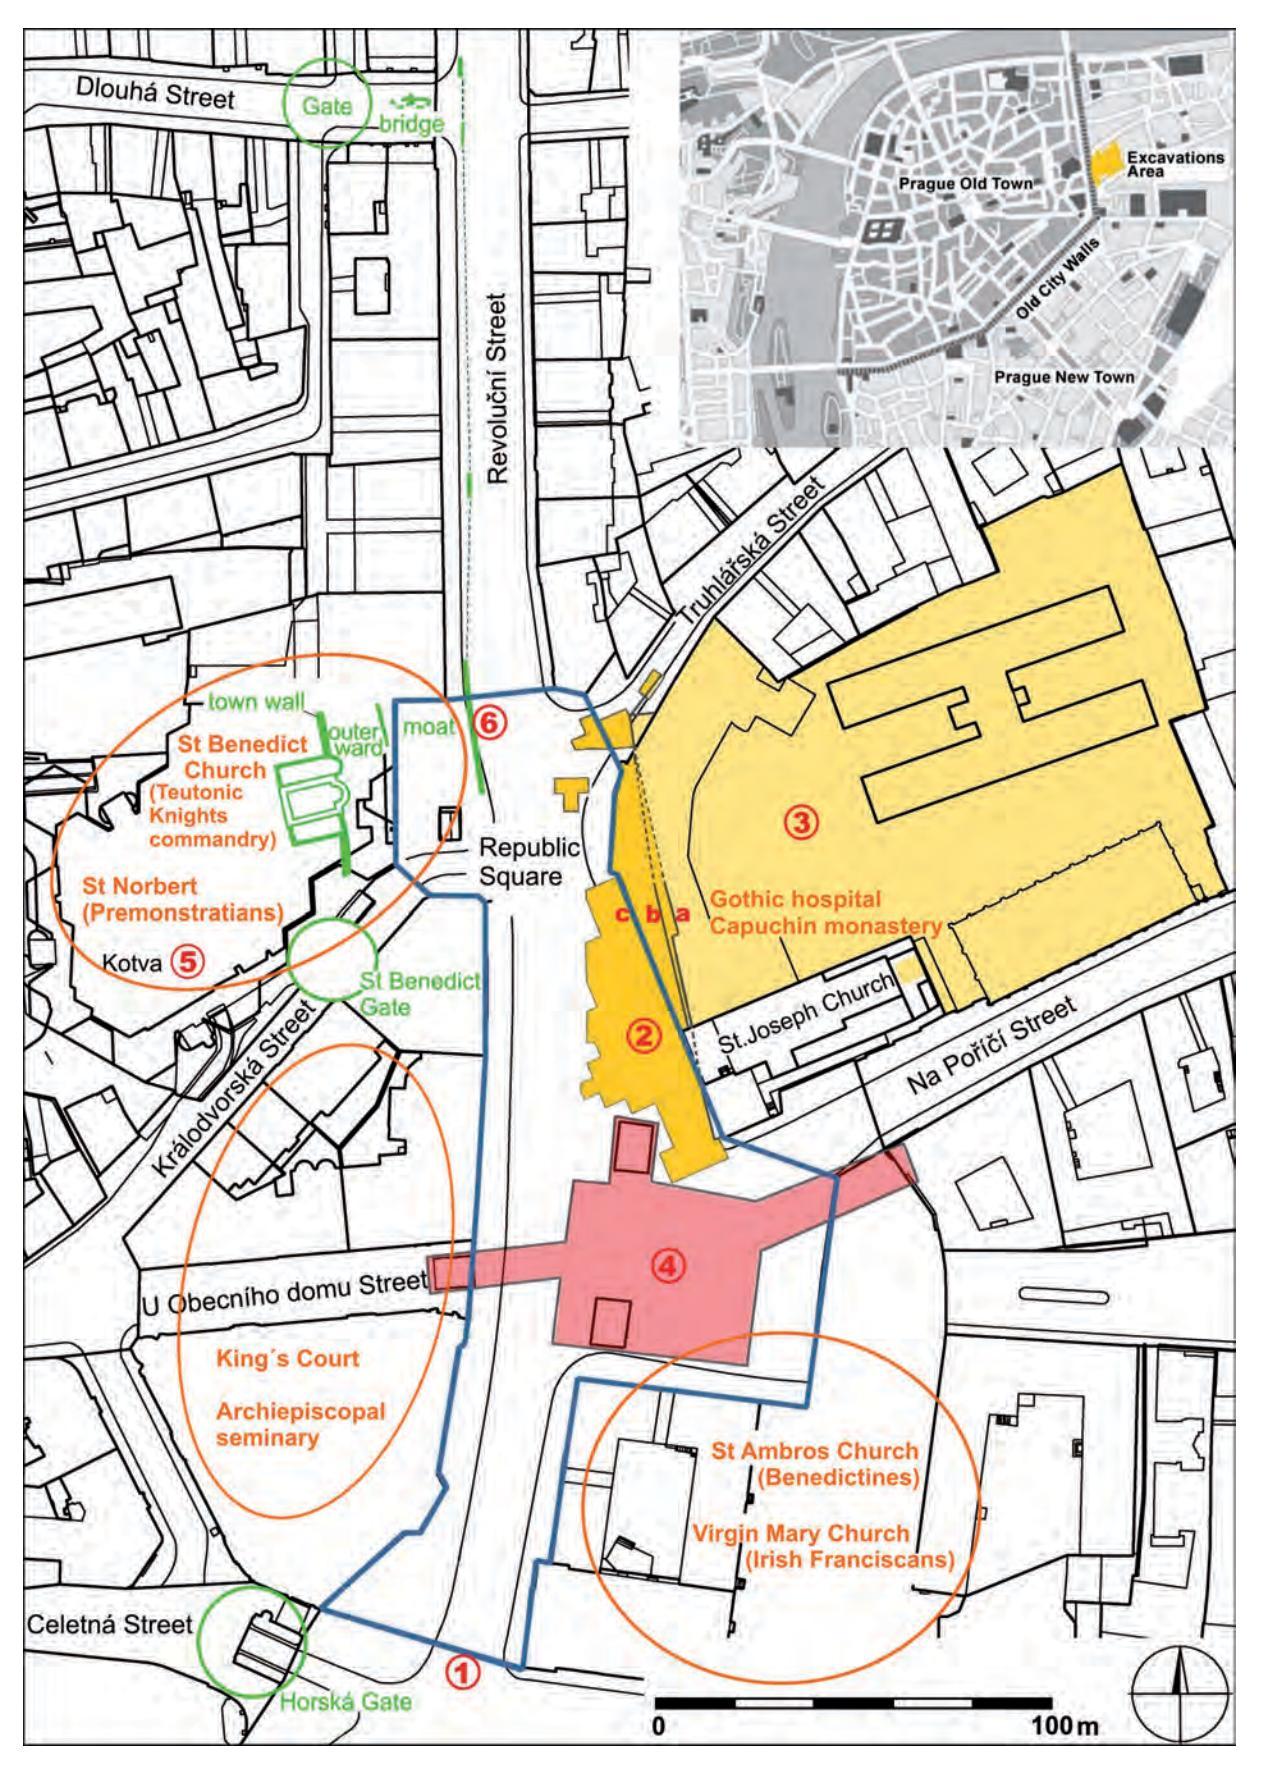
Fig. 1. Plan of Republic Square: 1 – boundary of present-day square; 2 – excavations area; 3 – excavations area of contemporary and historical public space; 4 – area destroyed during the construction of metro station; 5 – excavations area in 1971; 6 – uncovered remains of Old-Town fortification system; a – frontage line of a medieval development; b – frontage line of baroque development; c – frontage line of 19<sup>th</sup> century barracks

The face of the extensive area on the right bank of the Vltava River to the south and east of Prague's Old Town (Staré Město pražské) began undergoing fundamental and rapid transformation from the mid– 14<sup>th</sup> century. In 1348, the ruler Charles IV founded the grandly conceived New Town in Prague (Nové Město pražské), which had three main market areas – Koňský Trh (the Horse Market, now Wenceslas Square), Dobytčí Trh (the Cattle Market, now Charles Square), and Senný Trh (the Hay Market, now Senovážné Square). However, in addition to these main squares, other open areas of less importance, and above all of a different character, also emerged or continued to develop. One such place was the area that later became known as Republic Square (Náměstí Republiky) in the northern part of New Town in Prague (fig. 1:1).

In 2003–2006, an extensive archaeological excavation was conducted in the area of the former military barracks of Jiří z Poděbrad on Náměstí Republiky in Prague (fig. 1:2, 3). The actual site excavation was preceded by test trenching to determine the necessary duration and financial costs of the research (Juřina 1998; Ernée et al. 2002). The partly built-up area located between the streets of Na Poříčí, Truhlářská, and Náměstí Republiky, covering a total area of 1.5 ha, was for reasons of time and expertise divided up between four archaeological institutions (Havrda et al. 2004–2005; Juřina et al. 2006). The uniform approach applied in the excavation, the standardisation of documentation and recording methods in the field and of the subsequent basic processing of data (which should be completed by the end of 2009), and the close cooperation between all the institutions, served to guarantee the possibility of more detailed processing and publication of the findings from the excavation in the future (Juřina a kol. 2007). The excavation area was divided into a grid of  $4\times4$  m square trenches oriented along the southern boundary of the excavated site. The squares were excavated using the chessboard method and the entire excavation site was gradually dug down to the level of the geological subsoil, including all the sunken sites. All the situations uncovered in the site probes were documented using photogrammetric methods, and all the profiles were documented in drawings.

earlier excavation in 1971, it was possible to determine that the width of the moat at this place was 21 m across (Ječný 1978). If we add on the 12-metre outer ward, the total width of the fortification in the area of Náměstí Republiky was 35 m (fig. 1:6).

of the emerging Nové Město. This fact is supported by the above-mentioned strip of stone-pitching road with clear traces of worn-out wagon tracks running in a northwest-southeast direction, which the newly laid-out street line then followed (fig. 1:a). However, it must be noted that the new allotments were not laid out on 'greenfields' even here. A major discovery was an early Gothic stone building at the point where Náměstí Republiky meets Na Poříčí Street, which was later incorporated into the street front of

Another major change in the face of this part of the square came with the construction of the new military barracks buildings during the  $19^{\text{th}}$  century. In 1853, the main barracks building was completed, which now forms the façade onto the square. The construction of this building reduced the size of the historical public space by 400 m<sup>2</sup> and considerably altered the line of the eastern street front (fig. 1:c).

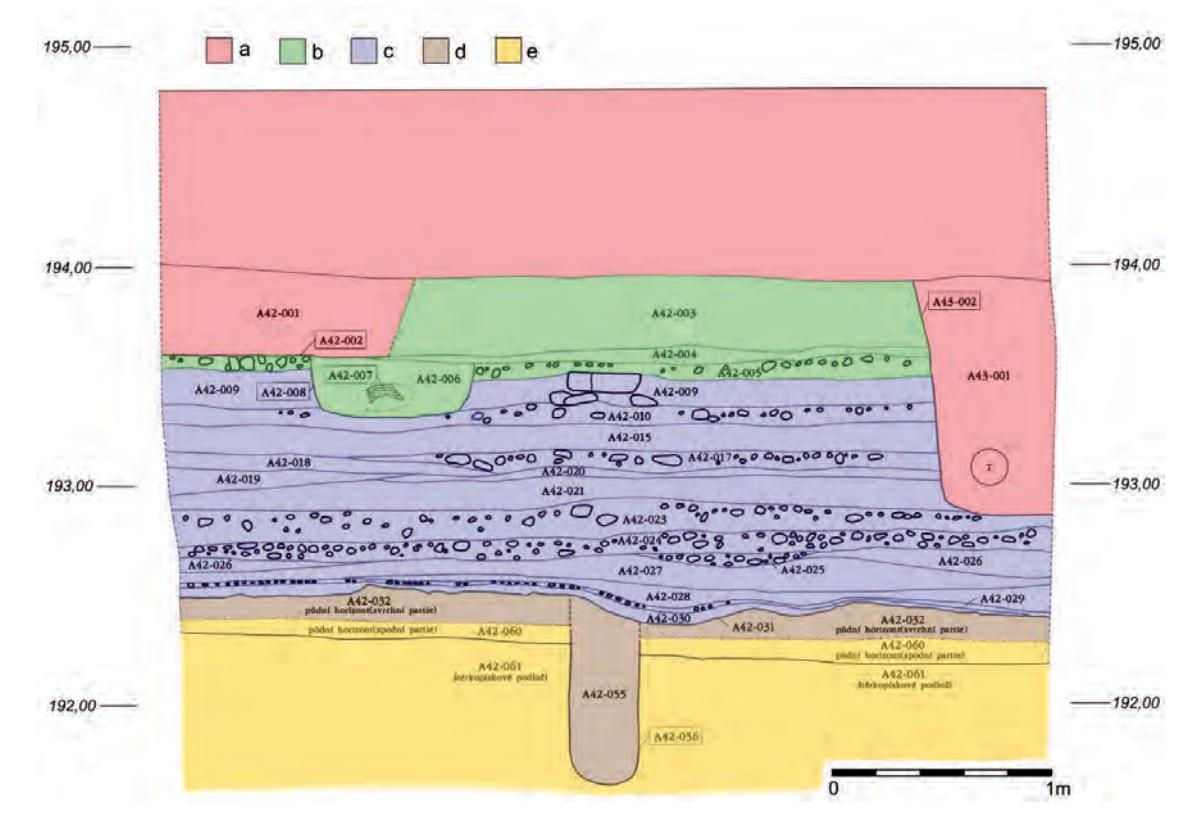
Fig. 2. Example of the strata typical for the area of the square: a – 19<sup>th</sup>–20<sup>th</sup> centuries; b – 16<sup>th</sup>–18<sup>th</sup> centuries; c – 2<sup>nd</sup> half of the 13<sup>th</sup>–1<sup>st</sup> half of the 13<sup>th</sup> century; d – 2<sup>nd</sup> half of the 12<sup>th</sup>–1<sup>st</sup> half of the 13<sup>th</sup> century; e – subsoil

slab, concrete and loose material foundation. This dramatic modification of the entire surface area of the site during the 20<sup>th</sup> century is what most likely destroyed part of the historical top layer dating to the late mediaeval and early modern periods. Other forms of recent interference in the excavated site mainly relate to the digging of trenches for the underground utility mains (the water, gas, and sewer systems) and the concrete foundations for street lamps. Despite these interferences, the site still represented a very well preserved and integral historical public space with an approximately 1.5-metre thick strata dating to the high middle ages (fig. 2).

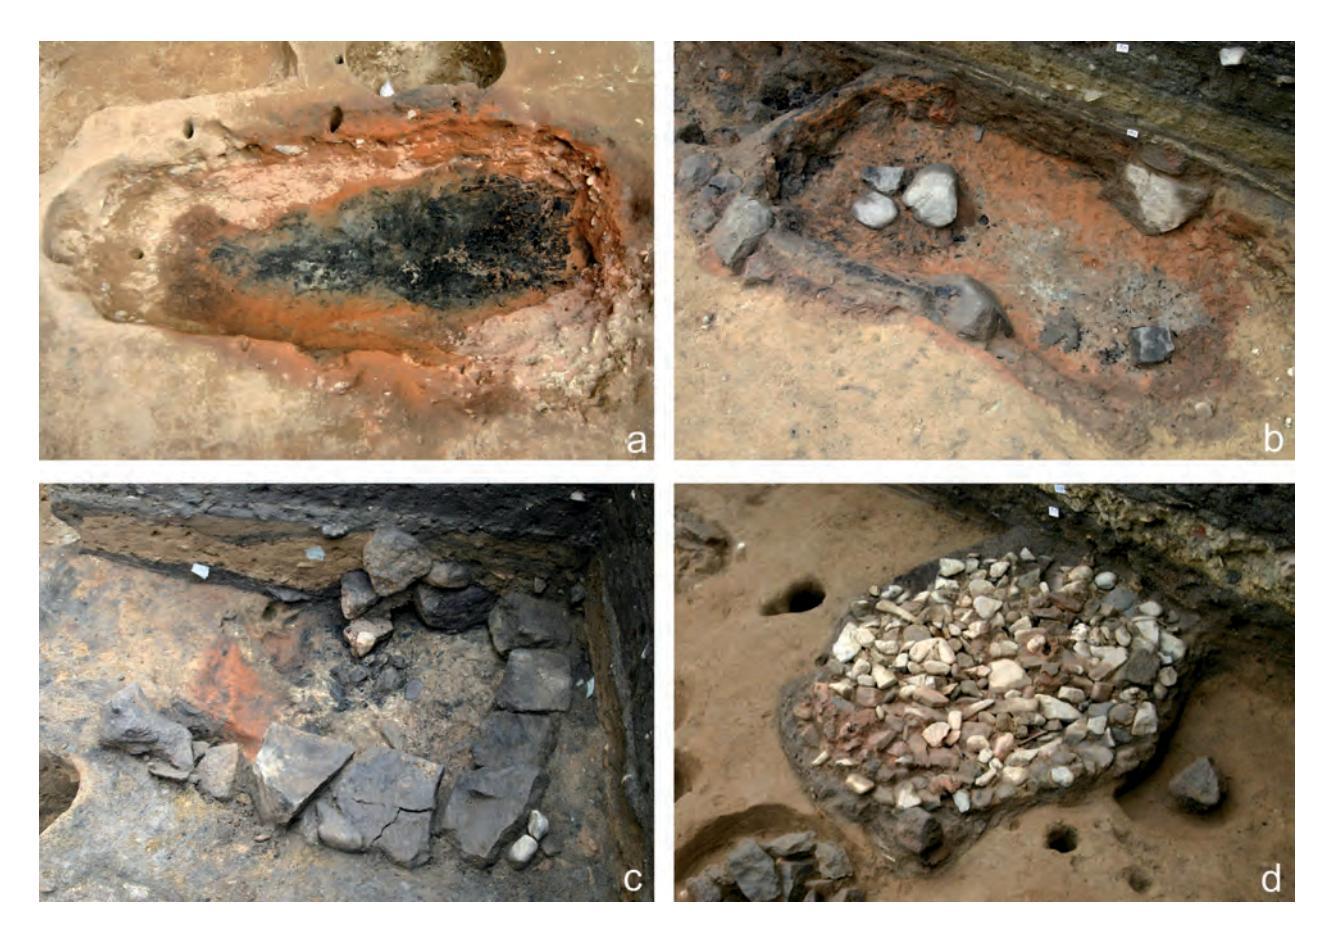
Fig. 3. Remains of heat-based technology structures: a-b – heating furnaces; c – kiln; d – fireplace – after removal of clay surface

up of two rows of diabase stones with a clay O-ring set on top. Fill of this pit was made up of clayey sandgravel with bits of fired clay, pieces of cinders, and small fragments of non-ferrous metals (Vyšohlíd 2007; in print). An accumulation of heating furnaces was also uncovered at two spots, each of which had a superposition of 4-5 objects of an oval layout 1.2-2.2 m in length and 0.75-1.1 m in width. The fill of the tub-shaped structures with burnt walls, sunk to a maximum depth of 0.4 m into the soil horizon, contained numerous pieces of diabase stones and river pebbles that had been exposed to very high heat, and there was also a large amount of cinders and ash. These simple structures, the original appearance of which is still unclear, tend to be associated with ferrous metallurgy (Havrda et al. 2001; Podliska, Zavřel 2006). Support for this connection can also be found in one of the nearby pits, which was filled with slag (circa 3 kg). More pieces of diabases, minettes, and river pebbles showing traces of heat were found in many of the layers covering these remains. These layers showed evidence of disturbance and destruction of many other pits at the time they became defunct. Eight other individual, and usually smaller, heating furnaces were also found. Another category was made up of the remains of some light wooden right-angled structures that were found in three cases. These were fragments of the foundation furrows for wooden beams, suggesting the existence here of cribwork buildings. The only fully surviving ground plan was 3.5×3.7 m in size (an area of

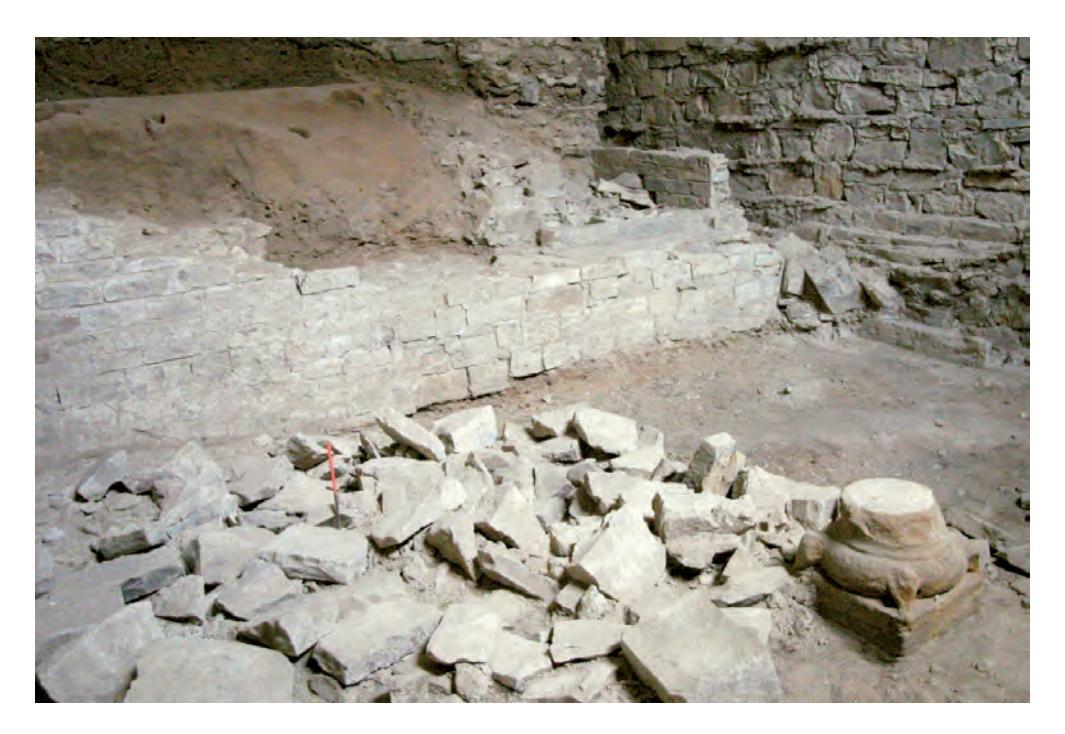
Fig. 4. Remains of Romanesque palace (2<sup>nd</sup> half of the 12<sup>th</sup> century)

stone architecture, walled with carefully hewn blocks of plaener stone. This expansive palatial charakter house with large two-part cellar space on a northsouth axis (and an internal ground plan of 19 m  $\times$ 5.5 m) was originally divided up by groin vaults set on sandstone columns (fig. 4). The unique character of this structure is also evident from the fragment of a cesspit uncovered along the north wall of the palace (a square ground plan with an inside edge 1.8 m in length and a maximum preserved height of 4.4 m), where there were finds of glass and leaded window rods (Juřina 2006). The second, smaller, stone building was uncovered on the actual site of the former military barracks, as was the third building, in which the only walled element was the entrance (Dragoun 2008).

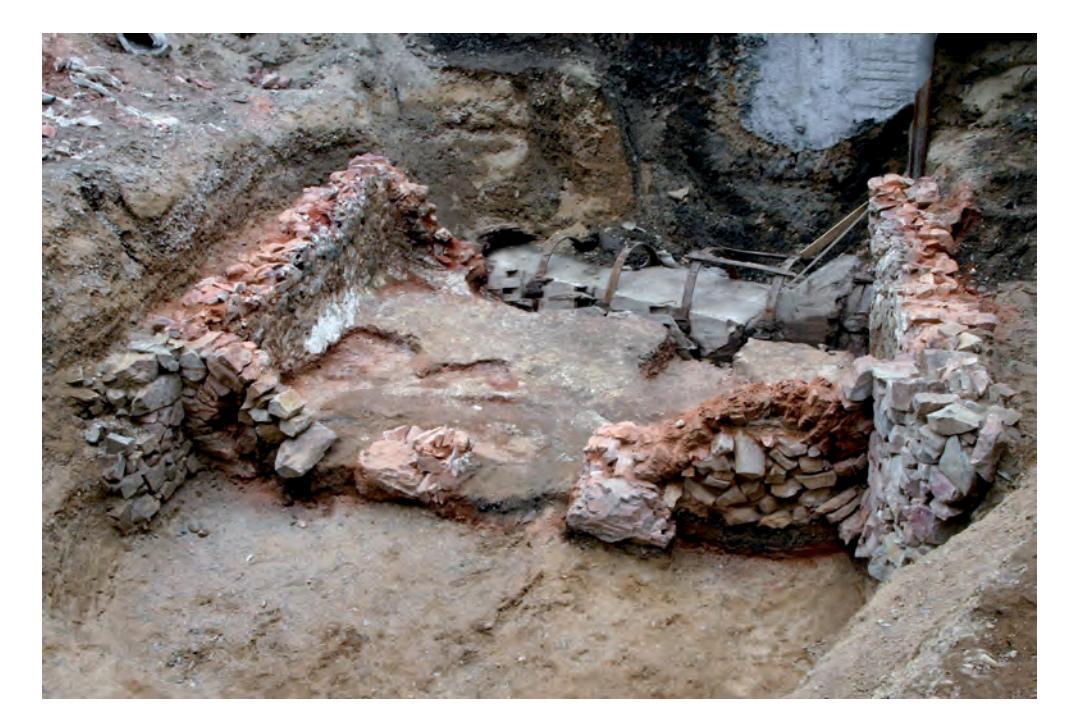
Fig. 5. Fragment of a kiln used to produce lime that was uncovered on the square

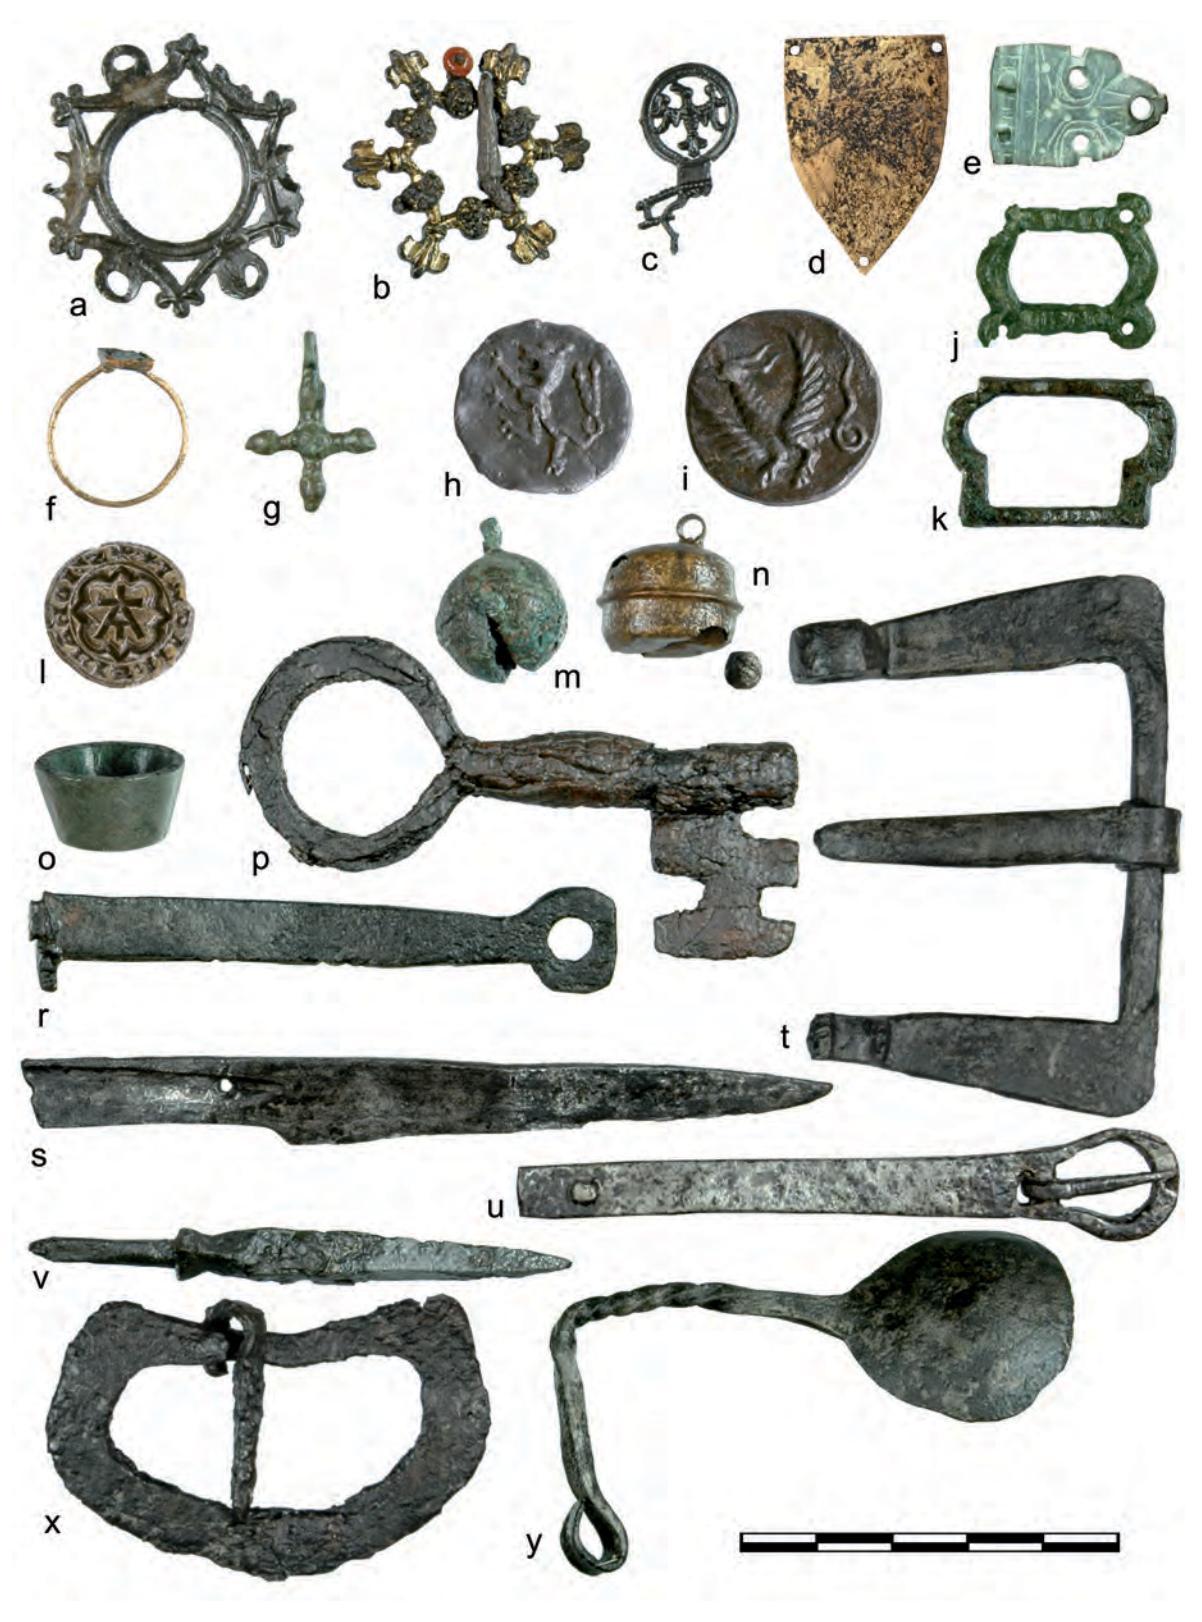
Fig. 6. A selection of artefacts: a-o - non-ferrous metal artefacts; p-y - iron artefacts

The stock of founded artefacts from the site of the square includes not just the above-mentioned organic waste, such as strips of wood, skin, and numerous bones, but also a rich inventory of metal artefacts. The main iron artefacts were horseshoes, bits, and spurs (in one case a cart-wheel fitting), which suggests that there was a great deal of horse traffic in the area of the public space. When the distribution of the horseshoes (circa 180 pieces) is plotted on the entire area of the excavation grid, we find that 56% of these finds (100 pieces) are concentrated in merely 13% of the excavated area of the public space. This percentage is even greater if we exclude finds from the rest of the excavation site that do not date to the period between the 2<sup>nd</sup> half of the 13<sup>th</sup> century and the 1<sup>st</sup> half of the 14th century focused on here. Another example of finds typical for a public space is 'lost items' – that is, objects lost by people as they passed through the area. These include small artefacts, such as clothing appliqués made of non-ferrous metal, iron keys, small knives, but also personal seals (2 pieces), small coins, scale weights, clasps and small bells (fig. 6). This inventory of artefacts also includes small ceramic statues (small horses and human figures). A special category consists of artefacts made out of bone and intended for games (fig. 7). Almost 70 astragals, playing dices, and game stones were found in the total excavation site. Even in this case the objects are notably concentrated in the area of the public space. A full 54% of the artefacts (37 pieces) were thus concentrated within just 13% of the excavated site (Čechura, Vyšohlíd 2008). This provides us with a picture of a space with horses and people moving hectically about and where people also stopped a while - for games and to exchange information. Finds of a few coins (fewer than 20 pieces) and scale weights (3 pieces) may indicate the presence of a peripheral and less important (occasional) market.

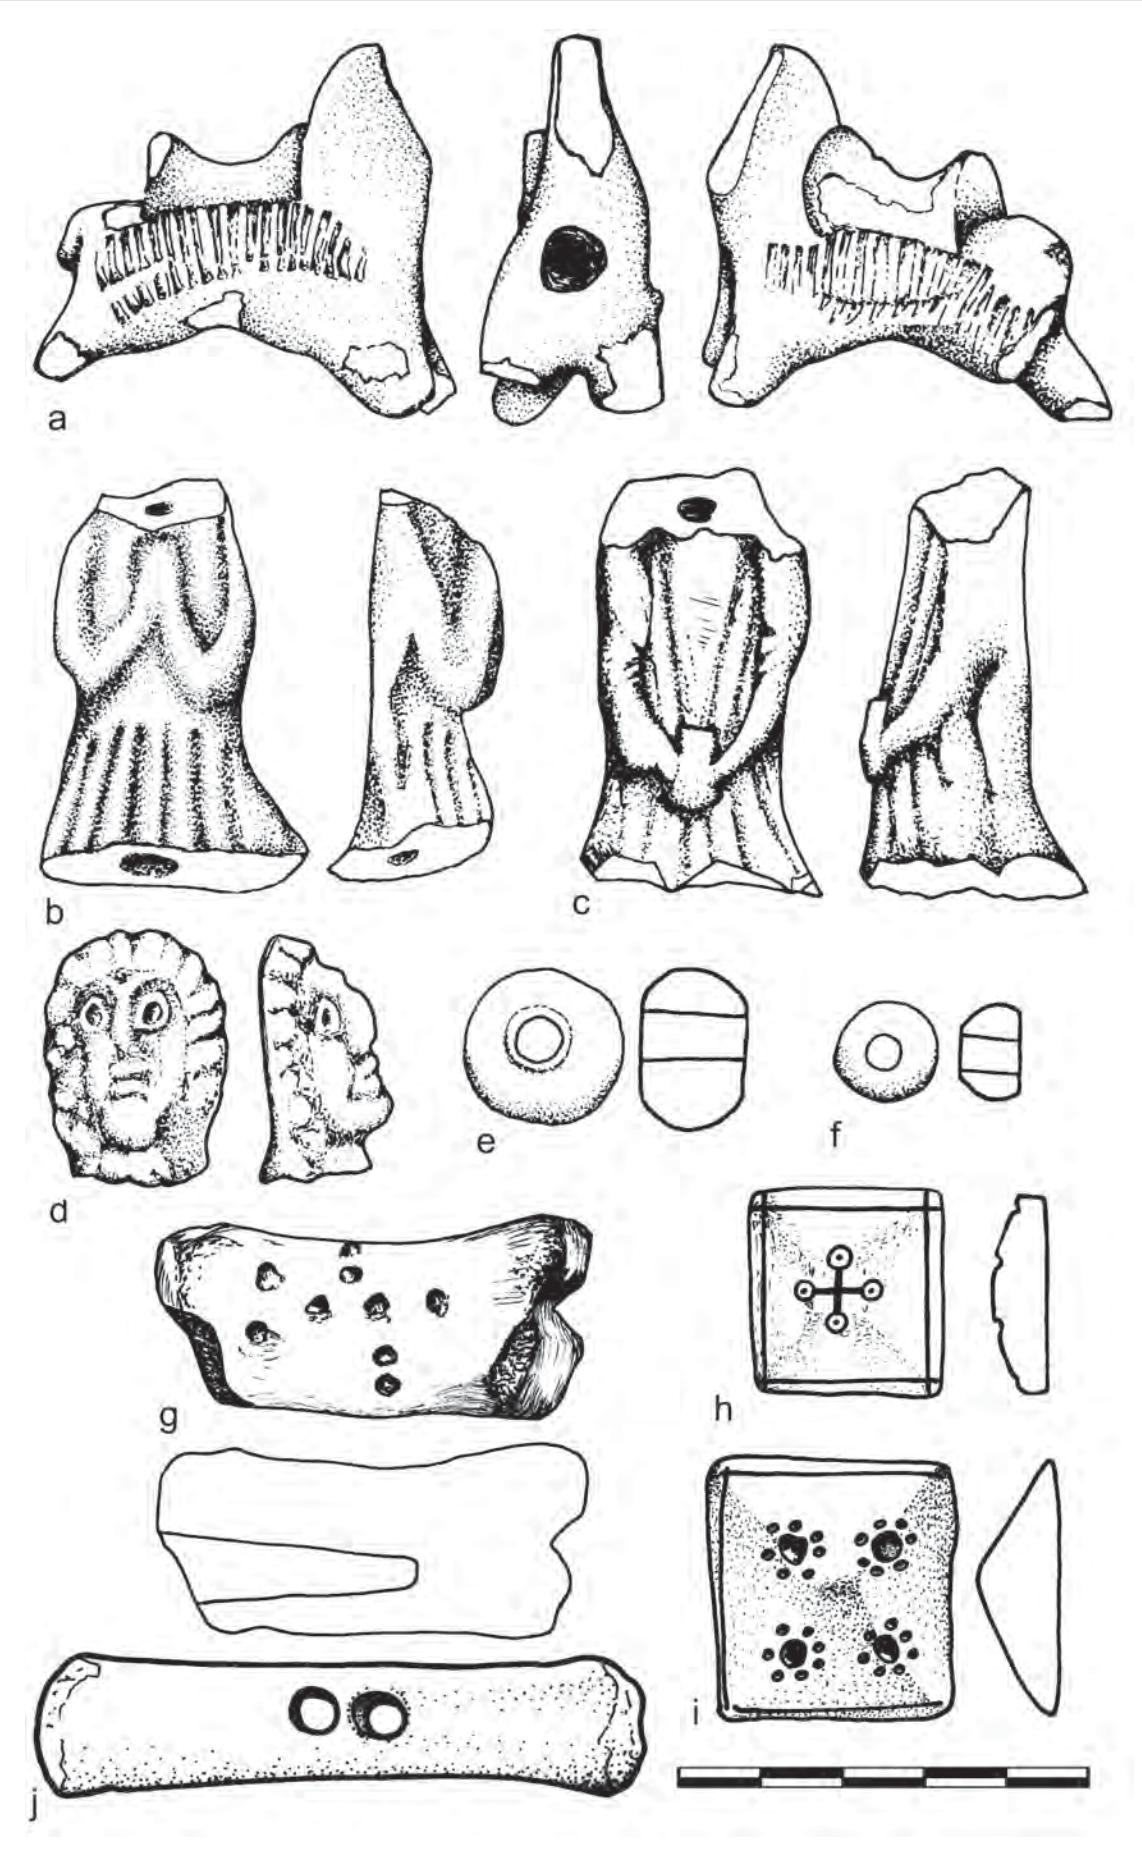
Fig. 7. A selection of artefacts: a-f – ceramic artefacts; g-j – bone artefacts

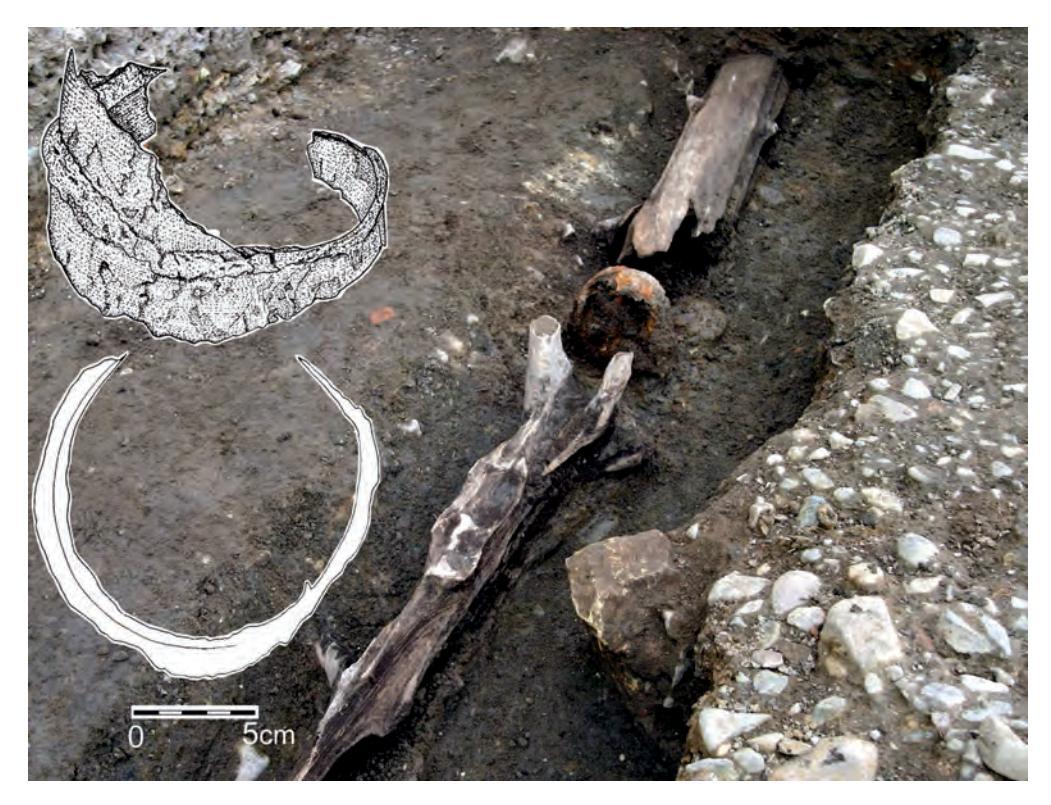
Fig. 8. Remains of an early modern wooden water main connected by iron conduit bushings.

destroyed by trenches from the later sewer systems. This water main was undoubtedly connected to one of the two water towers in Nové Město. For this part of town, that would have been the Novomlýnská Water Tower, which still stands today not far from the Vltava riverbank, 400 m north of Náměstí Republiky. The wooden water tower is first mentioned in writing in 1484. Following repeated renovations, the now stone tower acquired its current appearance after the mid-17<sup>th</sup> century (Novotný 2008). The course of the mains in this area is confirmed in plans for the water-main system in the records of the New Town authority dating to 1728 and 1774. Unfortunately, in this case the archaeological dating is very complicated and can fall within a relatively long time frame (16th–18th centuries). In Prague, wooden water mains have been detected at numerous locations, and their identification was aided mainly by documentation in a site on Wenceslas Square, where wooden bored legs of 2-4 m in length were uncovered, connected by iron conduit bushings with a diameter of 56-152 mm, and with a height of 55-86 mm. The remains were dated to between the 15<sup>th</sup> and 17<sup>th</sup> centuries (Huml 1975). It is generally believed that these water distribution systems were placed at a depth of around 1 m. This fact is supported not just by arguments of practical logic (freezing depth), but also by some written records (Široký 2000, p. 366). The trenches dug for the water mains on Náměstí Republiky were just 0.3 m below the level of the highest preserved historical terrain. This fact may support the possibility suggested above that the historical strata was lowered during surfacing work on the square during the 19<sup>th</sup> and 20<sup>th</sup> centuries. Small fragments of paving from polished quarried stone mixed with river pabbles set on a bed of sand were uncovered in just two cases. The paving was found in the immediate vicinity of the street front (along the western edge of the historical public space) and was dated to the 16<sup>th</sup> century.
